Re: Notice of Intent to Suc under the Clean Water Act 33 U.S.C. §1251 et. seq.

Phase I Environmental Site Assessment for the Approximate 9-acre Johnson Ranch Drainage Easement Project in Bulverde, Comal County, Texas

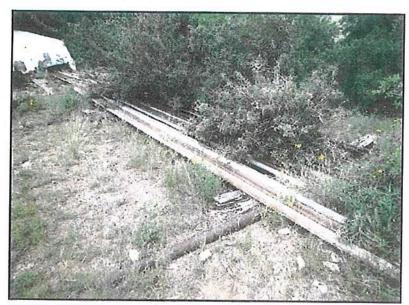
Figure F-8. Photo of abandoned pipes at dumpsite along west bank of the drainage.

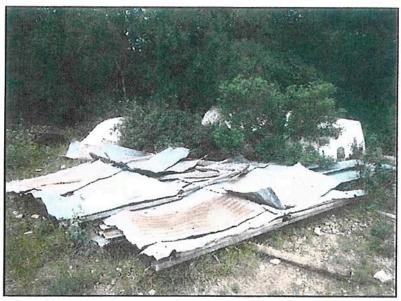
Figure F-9. Photo of corrugated metal and overturned fiberglass boat at dumpsite along west bank of the drainage.

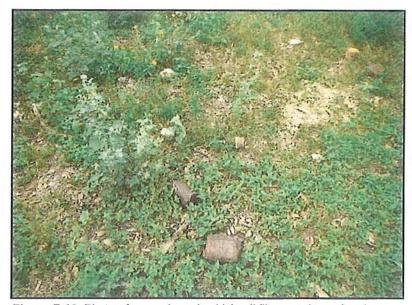
Figure F-10. Photo of several used vehicle oil filters at dumpsite along west bank of drainage.

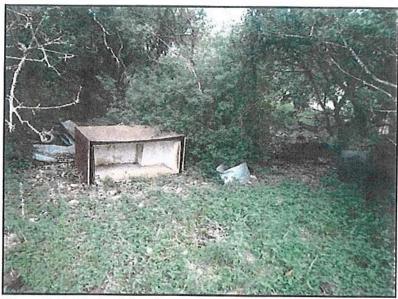
Figure F-11. Photo of abandoned refrigerator, scrap/corrugated metal, and possible water heater at dumpsite along west bank of drainage.

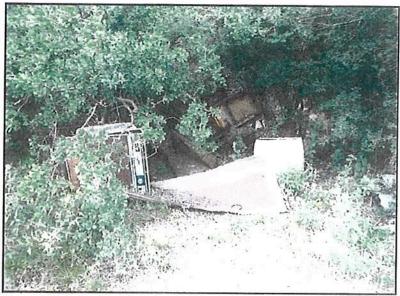
Figure F-12. Photo of abandoned dishwasher and other appliances and rusted scrap metal at dumpsite along west bank of drainage.

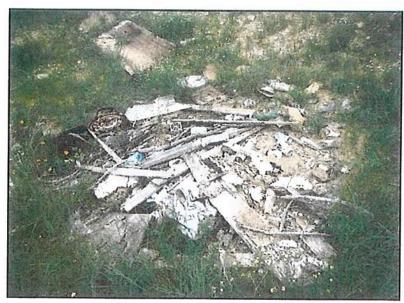
Figure F-13. Photo of miscellaneous items, such as wood, aluminum cans, metal and plastic scrap, and caulk tubes at dumpsite along west bank of drainage.

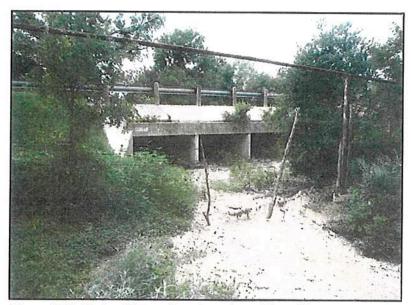
Figure F-14. Photo of the southern boundary of the subject property, facing south-southwest toward FM 1863.

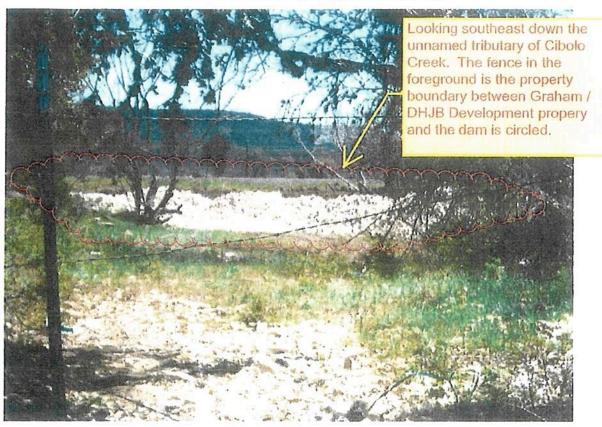
SUBJECT:	Looking downstream			
LOCATION: Unnamed tributary of Cibolo Creek off of Highway 1863			y 1863	
CITY:	Bulverde	COUNTY:	Comal	
DATE:	04/14/2014	GPS:	29,752262, -98.417028	
РНОТО NO.:	2		,

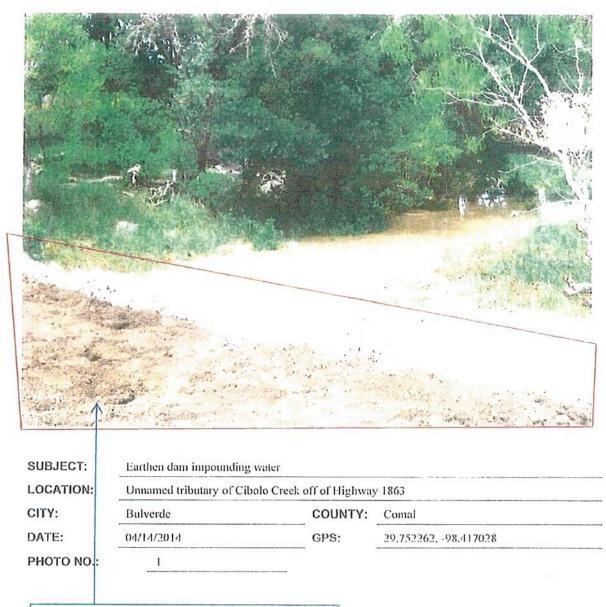
Standing on Dam (photo taken by TCEQ) looking northwest at water backing up

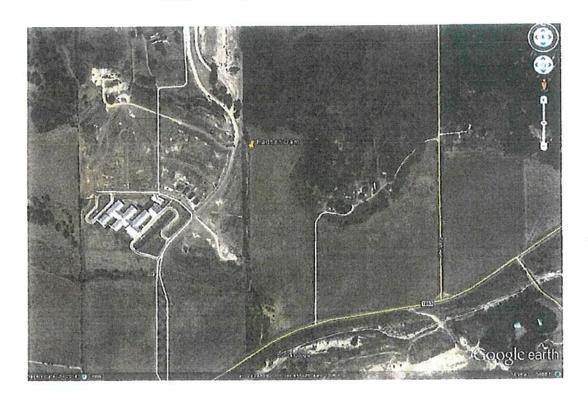
SUBJECT:	Satellite map of location of earthen dam			
LOCATION:	Unnamed tributary of Cibolo C	reck off of Highway	y 1863	
CITY:	Bulverde	COUNTY:	Comal	
DATE:	04/14/2014	GPS:	29,752262, -98.417028	
РНОТО NO.:	ı

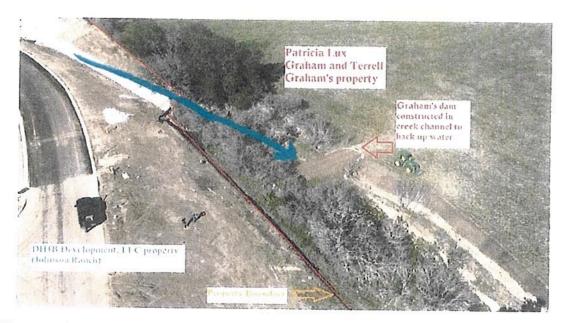
The majority of the southern portion of the Johnson Ranch subdivision drains to Channel A, paralleling Johnson Way, and leaves the property at a point approximately 2,100-ft north of FM 1863. In recent site visits at Johnson Ranch, I have observed that the natural channel downstream is blocked. From appearances, the downstream property owner has filled the natural channel with dirt and rock in an attempt to construct a dam to block water from leaving the Johnson Ranch property. See photo here illustrating the dam in the creek channel in relation to the property boundary:

We currently have no survey elevations of the dam but the location of the dam and visual observations made me believe that this blockage of the channel will impound water in the channel extending beyond the adjacent property owner's land and on to the Johnson Ranch development. This belief was confirmed with photographs taken shortly after heavy rains early on the morning of May 13, 2014 (see next page). This impoundment of water creates several practical problems for the development as well as a flooding and safety hazard. In many instances actions by a land owner causing water to back up on to an adjacent property owners land is a cause of action (damage) under the Texas Water Code.

I recommend the guidance of counsel familiar with the Texas Water Code be sought to evaluate actions required to cause this dam to be removed. Please do not hesitate to call or email me with any questions.

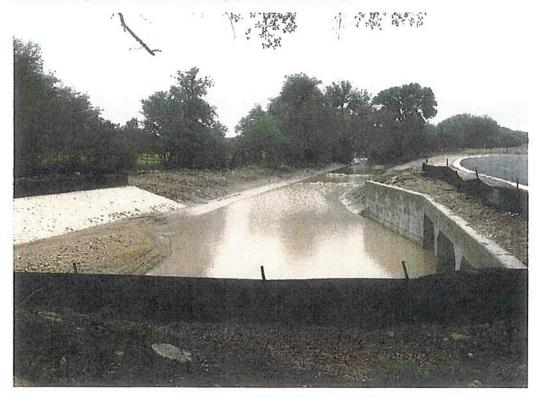
Photo 1: Looking downstream at water backing up from Graham property.

Graham dam

Property boundary fence line

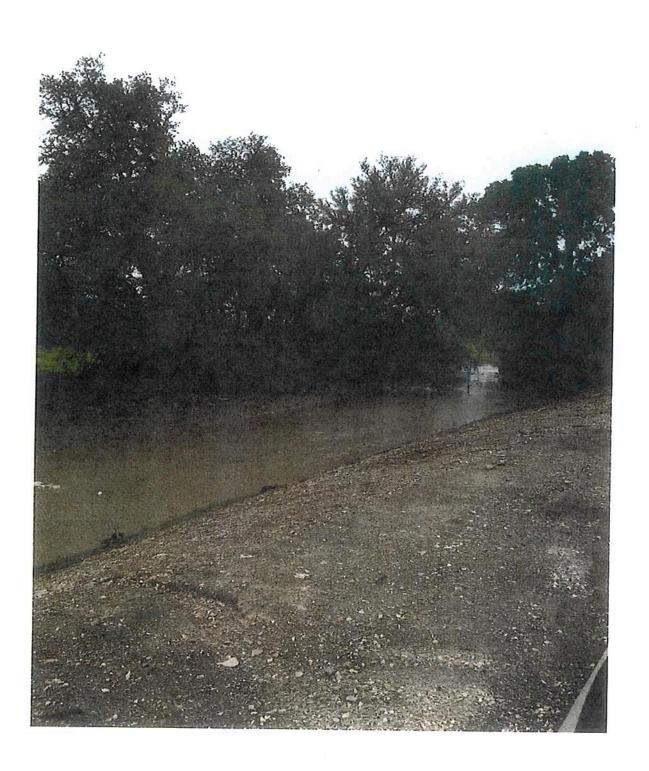
Looking downstream from fence line at Graham dam

Photo 3: Photo looking downstream at dam from property line.

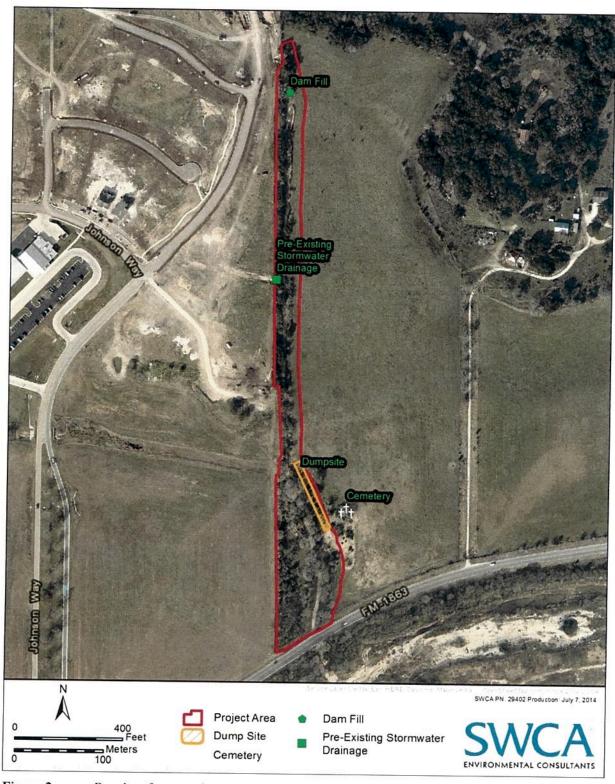
Figure 2. Results of reconnaissance.

- Evidence of Dumping SWCA identified one dumpsite within the subject property adjacent to the drainage (Figure 2). Discarded materials include lumber, plywood, corrugated metal, construction debris, scraps of hard plastic, old appliances, farming equipment, fiberglass boat, metal pipes, rusted wire, concrete chunks, small, rusted motors, water heater, portable propane tank, aluminum cans, and numerous used vehicle oil filters (Figures F-8 through F-13, Appendix F). There is potential for materials in these dumpsites to contain asbestos or lead-based paint. Should future construction activities affect this dumpsite, these items should be removed and disposed of properly. This item is considered to be a de minimis condition and to have a low level of environmental risk or liability.

- Presence of Fill Material SWCA identified a washed-out earthen dam (originally approximately 20 feet long, 3 feet high, and 6 feet wide) made from what appears to be native soil mixed with limestone cobbles within the northern portion of the subject property (Figure 2; Figures F-3 and F-4, Appendix F). SWCA does not have landowner confirmation on the source of the soil and limestone materials; however, no staining, foreign debris, or potential sources of hazardous materials were observed. Should future construction activities affect this area of the subject property, this material should be removed and disposed of properly. Should future excavation of this material uncover any potentially hazardous material,

- Runoff of Potential Contamination from Off-Site Sources SWCA identified two areas with potential to transport sediment and surface water runoff from off-site sources onto the subject property. Failed sediment control measures, or lack thereof, at the construction site at the northern end of the subject property may have allowed off-site discharges to reach the drainage within the subject property (Figure F-2, Appendix F). Also, the pre-existing stormwater drainage that flows into the subject property may transport off-site contamination onto the subject property as well. Should future construction activities affect these areas on the subject property, appropriate sediment and stormwater control measures would need to be implemented to protect the construction crews and surrounding public and prevent soil and water contamination. This item is considered to be a *de minimis* condition and to have a low level of environmental risk or liability.

SWCA conducted an on-site inspection on June 18, 2014. No recognized environmental conditions were identified. However, dumping activities, the presence of fill material, and the potential for contamination from off-site sources were identified as *de minimis* conditions on the subject property (see Figure 2).
